DEF Metering Unit Inlet Screen Clogging Due to Excessive Moisture in the Air System

42-69

**Freightliner
Service Bulletin**

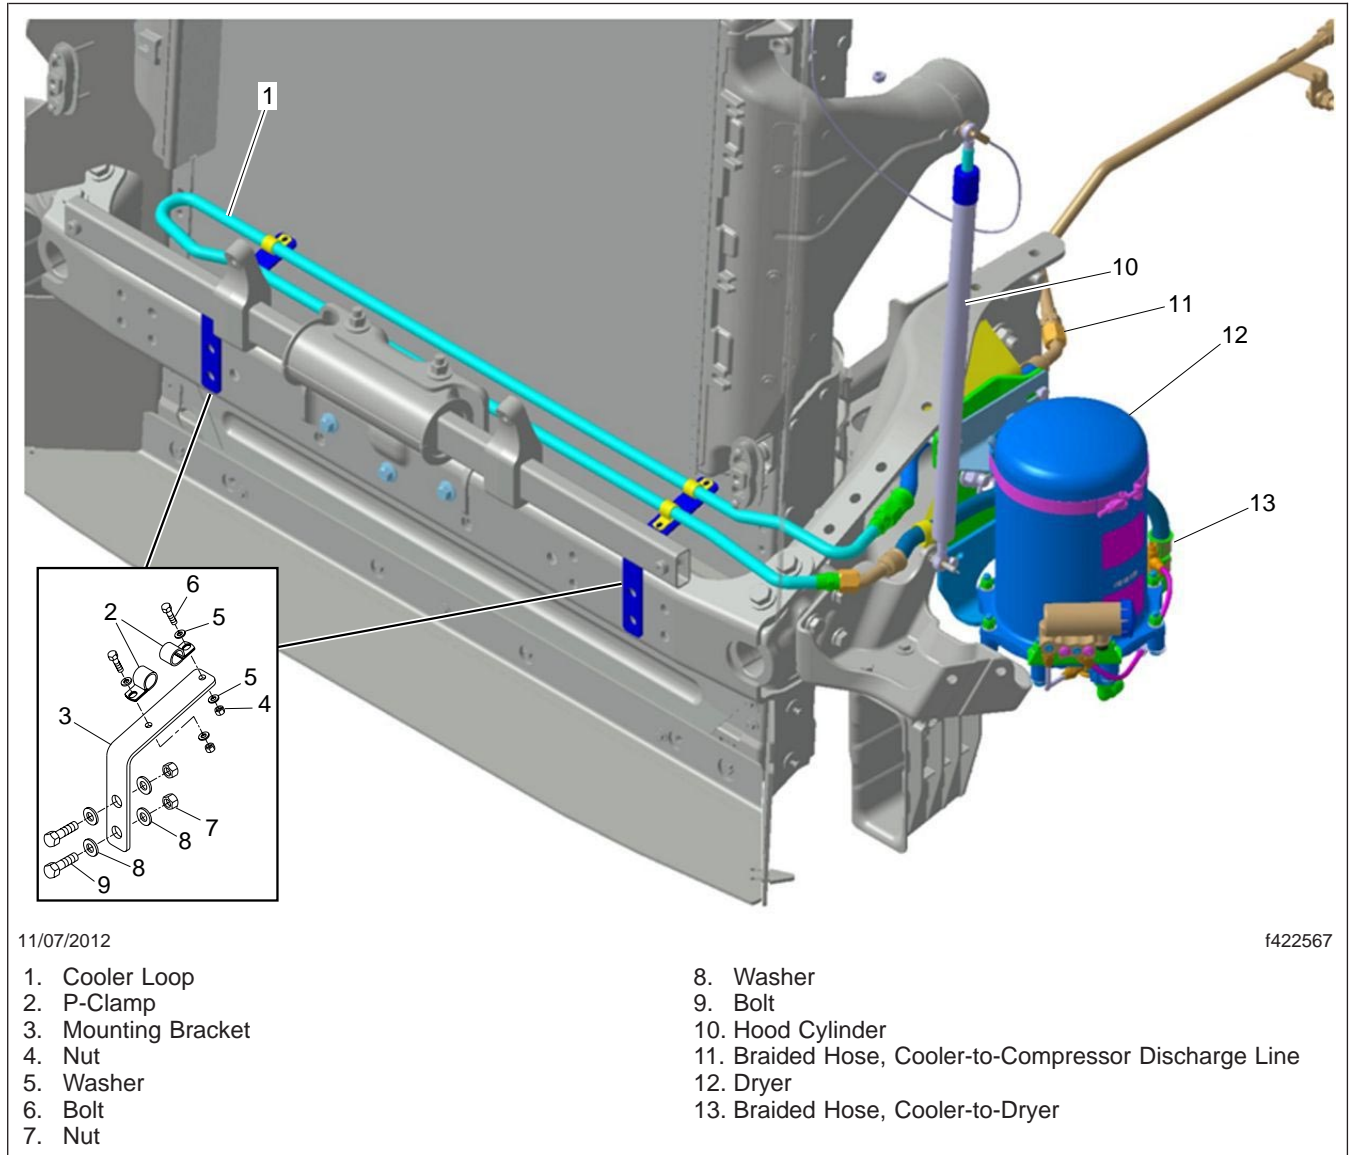
Fig. 1, Cooler Loop Installation (AD-9/AD-IP dryer shown)

If the issue persists, the air dryer inlet air temperature may be excessive, resulting in reduced dryer performance. Install an in-line air cooler loop.

8. Install the cooler-loop mounting brackets. See [Fig. 1](#).
9. Position the P-clamps on the cooler loop and install the cooler loop on the brackets. Do not tighten the P-clamp fasteners at this time. See [Fig. 1](#).

14. Secure any loose wires or hoses around the dryer with zip ties as needed.
15. Tighten the cooling loop mounting fasteners. See [Fig. 1](#).
16. Charge the air system and check the installation for leaks. Repair as needed.
