Service Alert CSP 06-16

ISX15 Single Lobe Camshaft

Product Affected: ISX CM2250SN

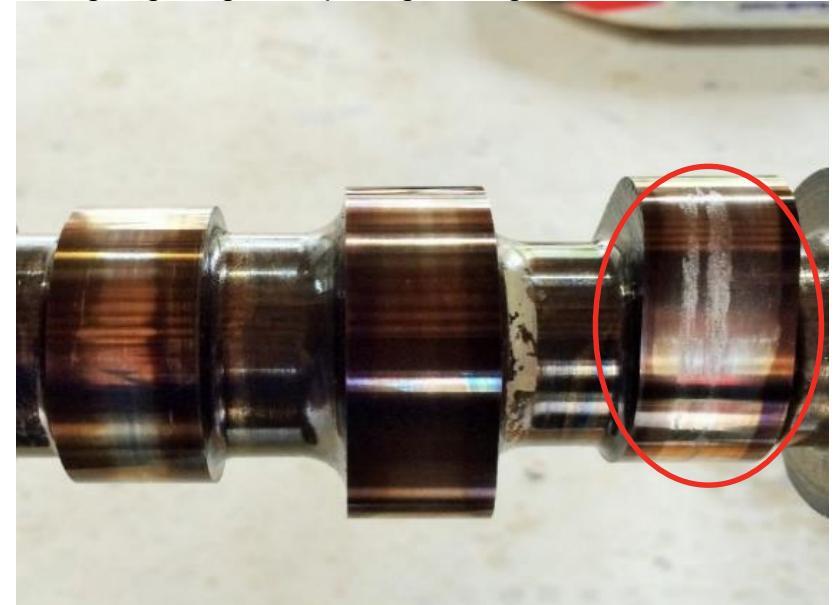
Single lobe camshaft failures typically occur due to excess friction at the roller to pin interface due to but not limited to insufficient running clearance, poor oil quality and/or excessive wear. This creates relative motion (skidding/slipping) between the roller and the cam lobe resulting in galling and spalling damage.

Image showing galling and spalling of a single camshaft lobe failure.

Inspect the camshaft for re-use following the service manual 4310736 section 2 procedure 175-002-024-tr on QSOL. Ensure to consult the service bulletin 3666052 as outlined in the service manual.

If this failure mode is observed during engine repair, even if it is not the primary failure mode, measure and record the valve lash prior to disassembly. Submit a TSR to return the parts to Cummins South Pacific Engineering. Repair ISX engine as per QSOL procedure.

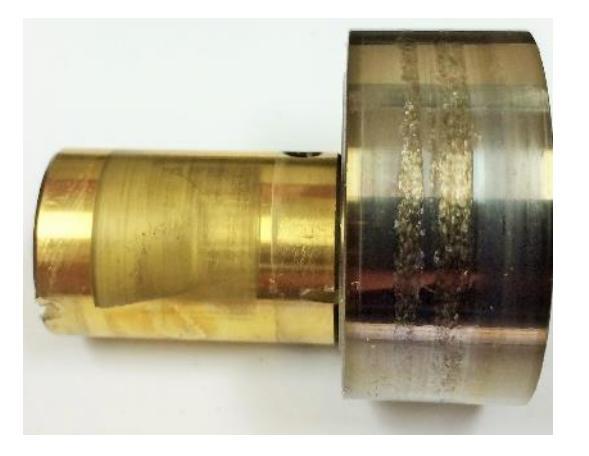
Wear on the roller to pin interface

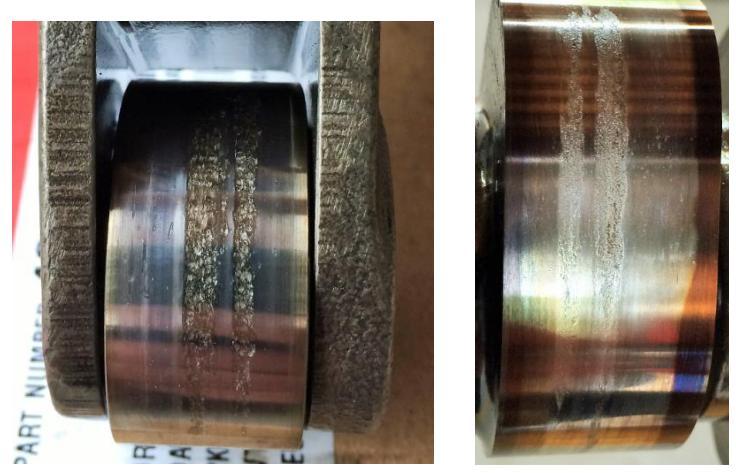
Galling and spalling on the exhaust roller and camshaft lobe
