Diesel Particulate Filter (DPF) - Excessive Brick Shift

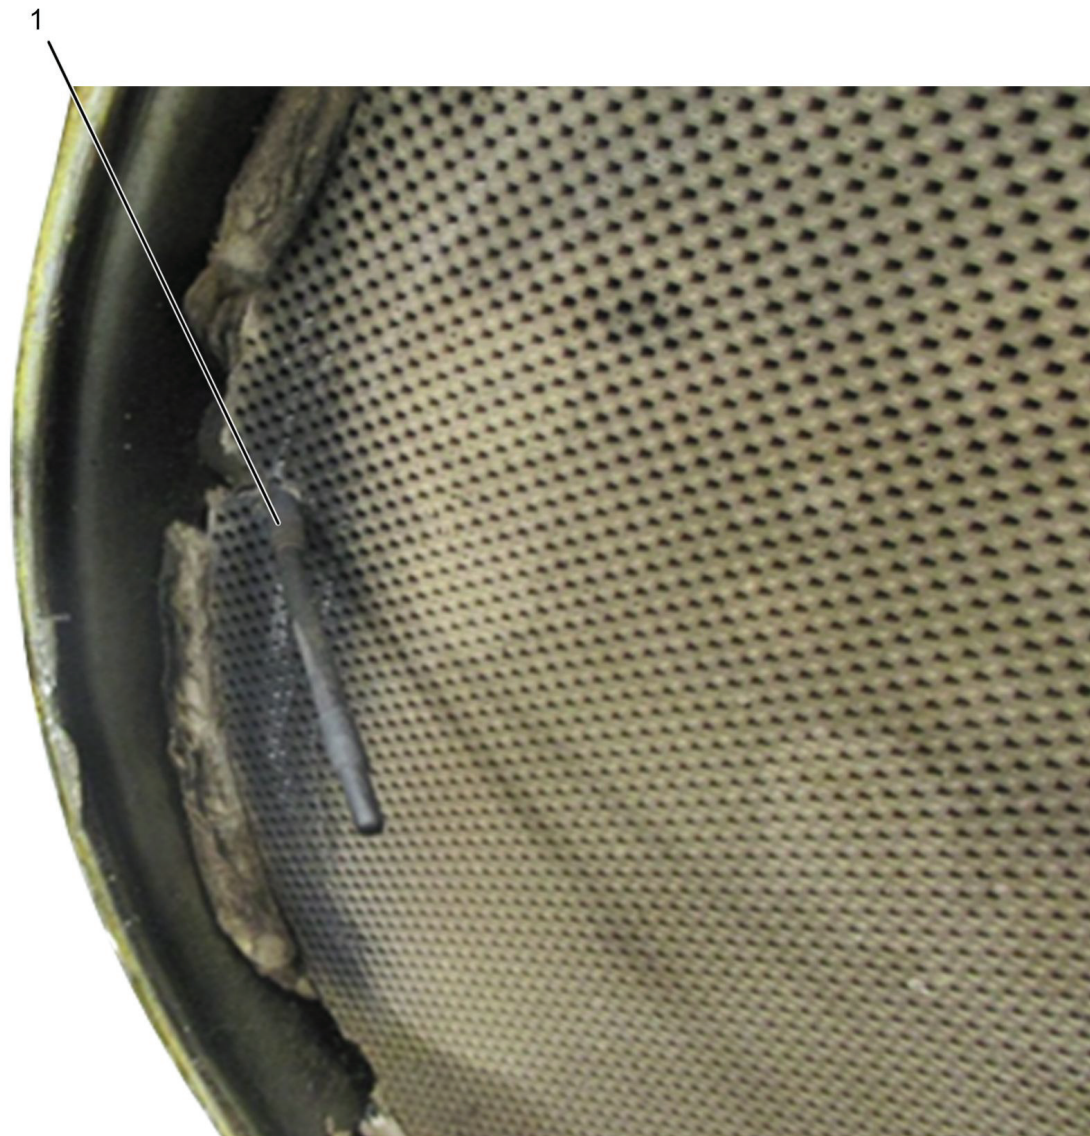
Figure 83 Diesel Particulate Filter (DPF) - Excessive Brick Shift.

Appearance	DPF brick has shifted past DPFOT sensor causing damage to DPF substrate.
Cause	Excessive soot accumulation caused by a base engine problem resulting in higher than normal exhaust back pressure.
Action	Diagnosis and repair root cause of excessive exhaust back pressure. After root cause is repaired, replace DPF.

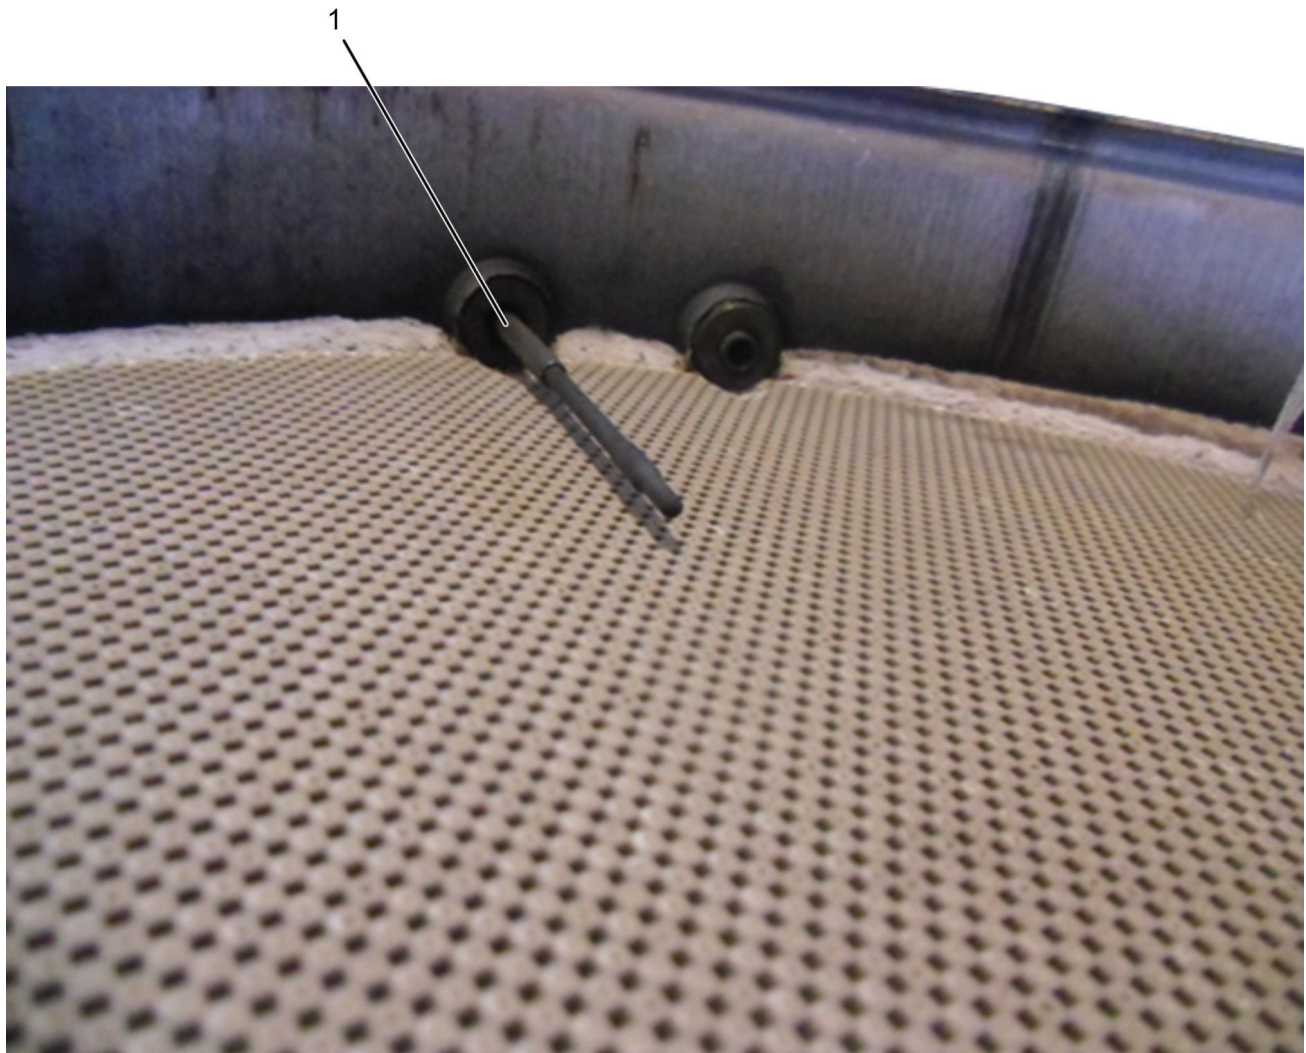
Figure 84 Diesel Particulate Filter (DPF) - Moderate Brick Shift.

Appearance	DPF brick has shifted and made contact with the DPFOT sensor port bung, but has not damaged the DPF substrate.
Cause	Excessive soot accumulation caused by a base engine problem resulting in higher than normal exhaust back pressure.
Action	Diagnosis and repair root cause of excessive exhaust back pressure. After root cause is repaired, perform DPF Snap Acceleration Test. If no black smoke is seen during the snap acceleration test, DPF can be reused.
