## Oil Filter and Oil Filter Standpipe Inspection

### Oil Filter Identification

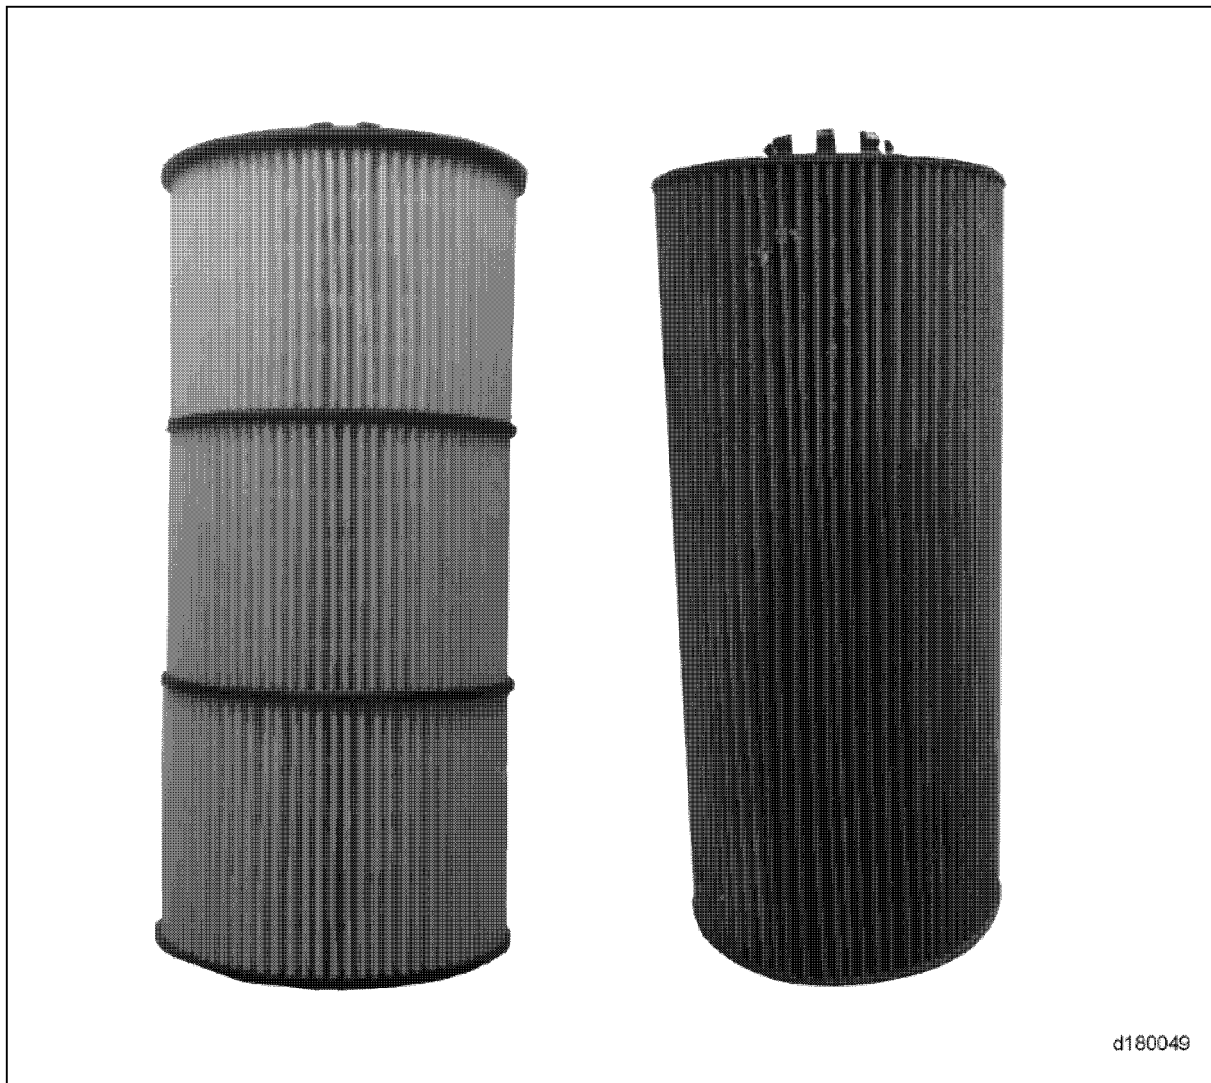
The oil filter used in the MBE 4000 engine is similar in size and fitment to the DD platform oil filter. However, an MBE 4000 oil filter must **not** be used in a DD engine. Damage to the oil filter bypass valve can occur if an incorrect oil filter is used. In addition, the MBE 4000 filter is not designed to handle the oil volume and pressures of a DD engine. The figure below shows the difference between the current DD oil filter and an MBE 4000 oil filter.

Fig 7.1, Current DD Oil Filter (left-new) and MBE 4000 Oil Filter (right-used)

The current oil filter used in DD engines is a stack design with no glue beads. It uses shorter pleats in conjunction with two additional discs in the middle of the filter. This design was released in early 2013 and has the highest quality of filtration. The original early design used six glue bead rings on the outside diameter of the oil filter. The Detroit-branded filter is the recommended oil filter for a DD engine.

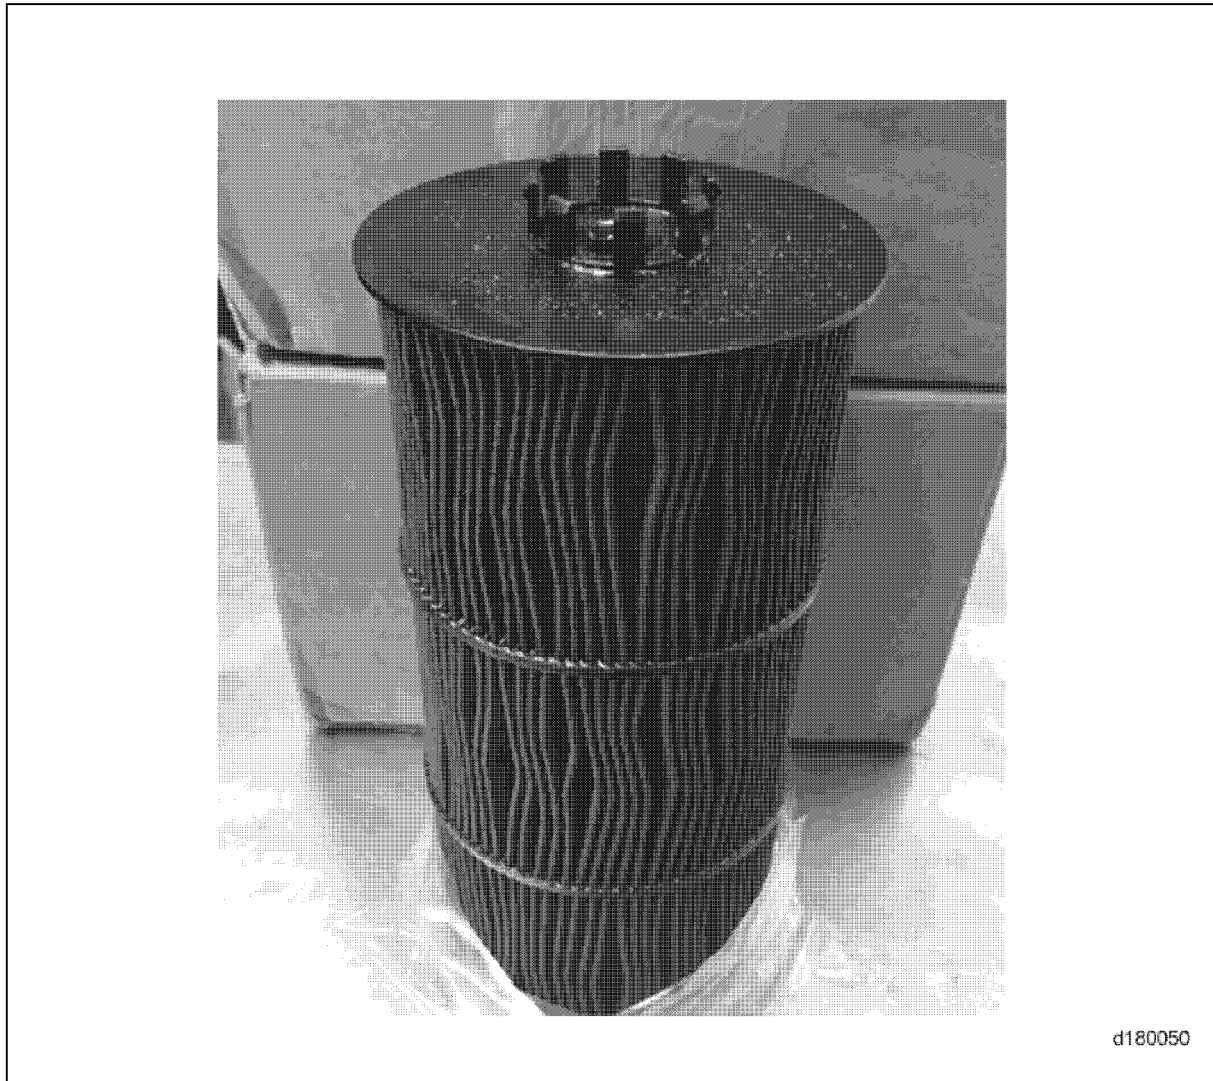
Coolant contamination of the oil filter will typically result in distorted oil filter pleats or sludge build-up, depending on how long the engine ran with coolant in the oil. See the figures below. The oil filter may be noticeably heavier due to the saturation of coolant. Coolant contamination of the lube system can be detrimental to the lower end bearings, as coolant does not provide the necessary lubricity. The source of the coolant contamination must be determined. Contaminated lubricating oil will be discussed later in this manual.

**Fig 7.2, Oil Filter Contaminated with Coolant**

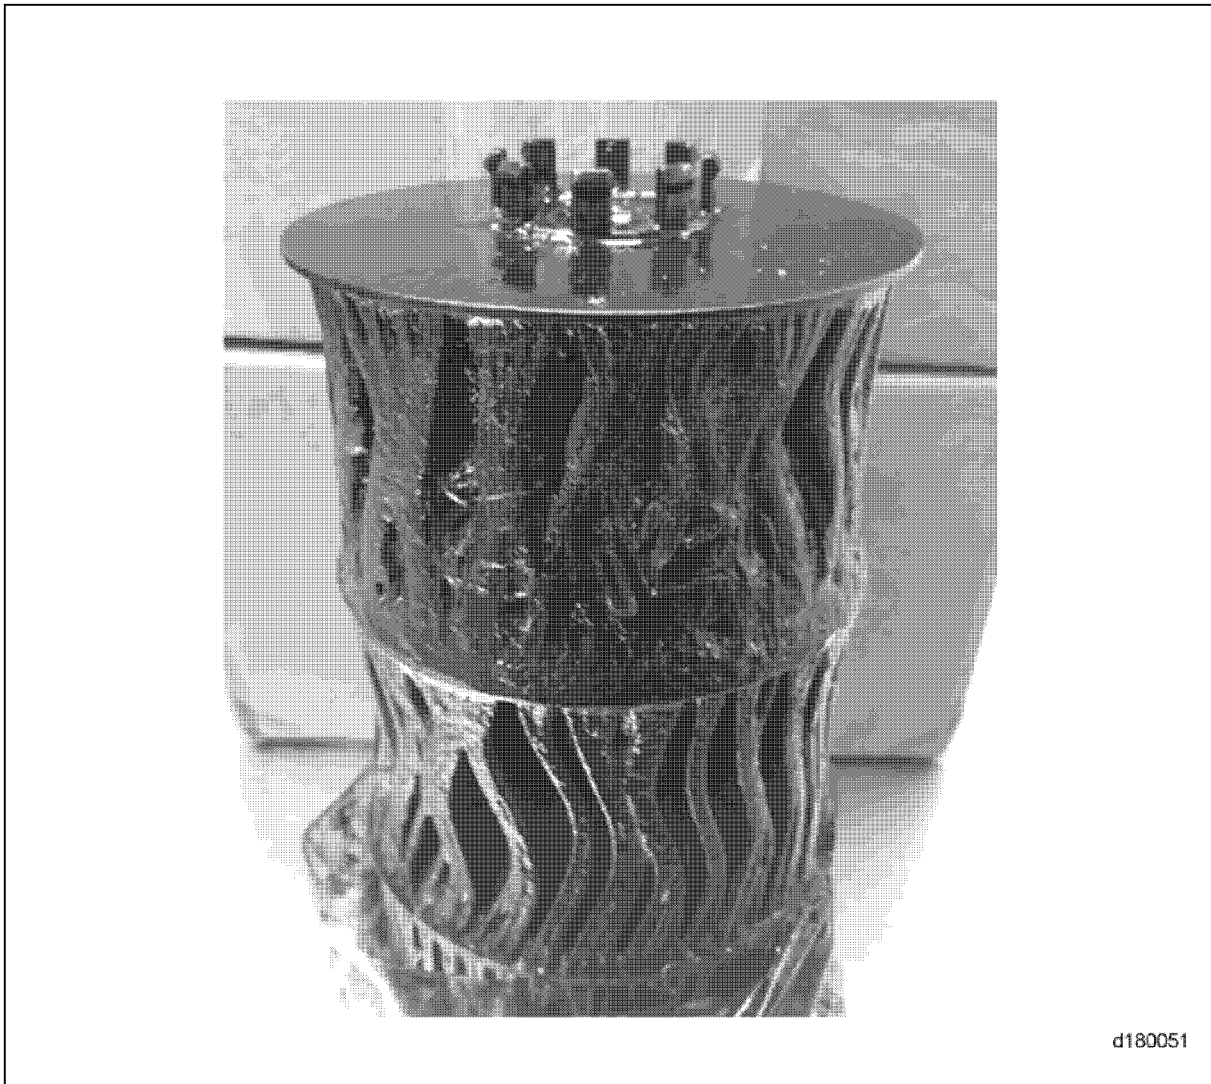
**Fig 7.3, Oil Filter Severely Contaminated with Coolant**

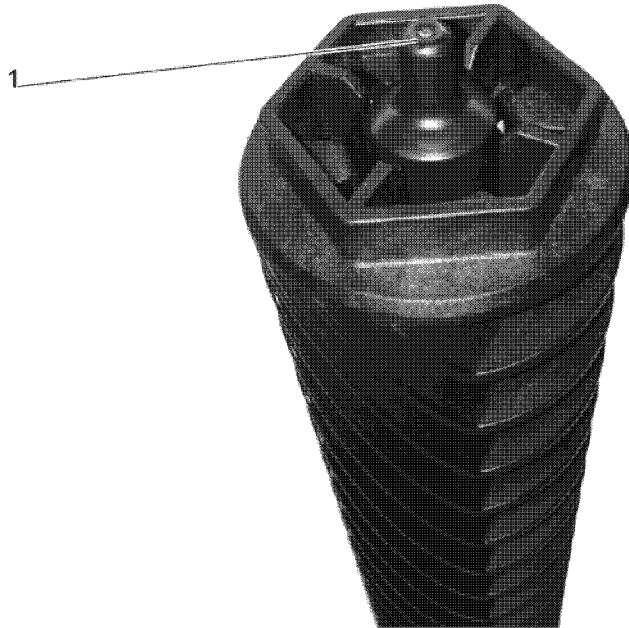
d180042

The oil filter standpipe is made of plastic and contains the oil filter bypass valve (1). See figure below. The bypass circuit is required to prevent oil filter pleat damage at cold engine start. The next figure shows a cutaway of the oil filter standpipe and the operation of the bypass valve.

1. Bypass Valve

Fig 7.4, Oil Filter Standpipe and Bypass Valve

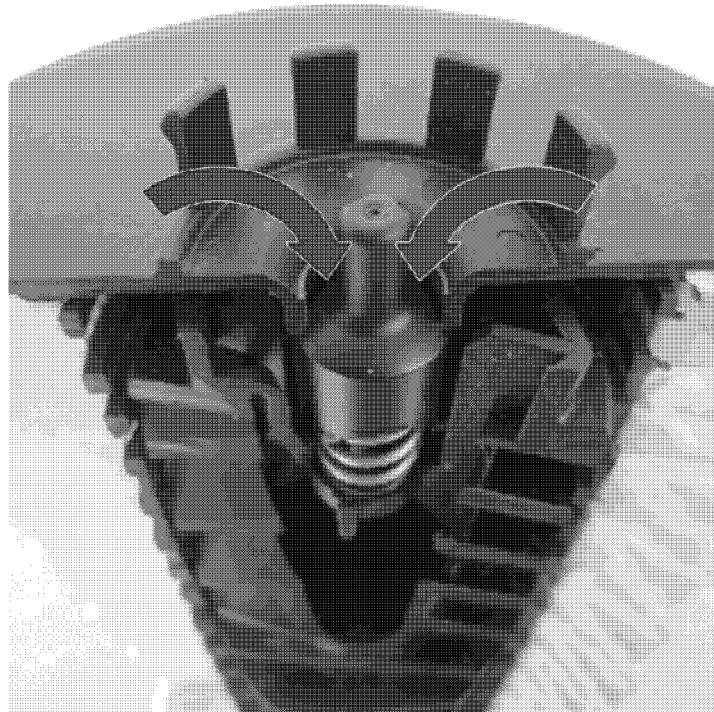
d180052

**Fig 7.5, Oil Filter Bypass Valve Operation (cutaway)**

When the engine is cold, a portion of the engine lubricating oil from the oil sump will bypass the oil filter and be delivered to the various components in the lube oil circuit, including the lower end bearings. Any debris that is small enough to make it through the oil suction manifold strainer, oil pump, oil cooler, and bypass valve can end up in the bearings due to cold oil filter bypass. For this reason, it is important to make clean repairs to the engine so debris is avoided. It is also important to follow the proper sequence for an oil change; oil filter first, then drain the oil pan. This allows any contaminants from the oil filter to drain back to the oil pan and be removed with the dirty engine oil.

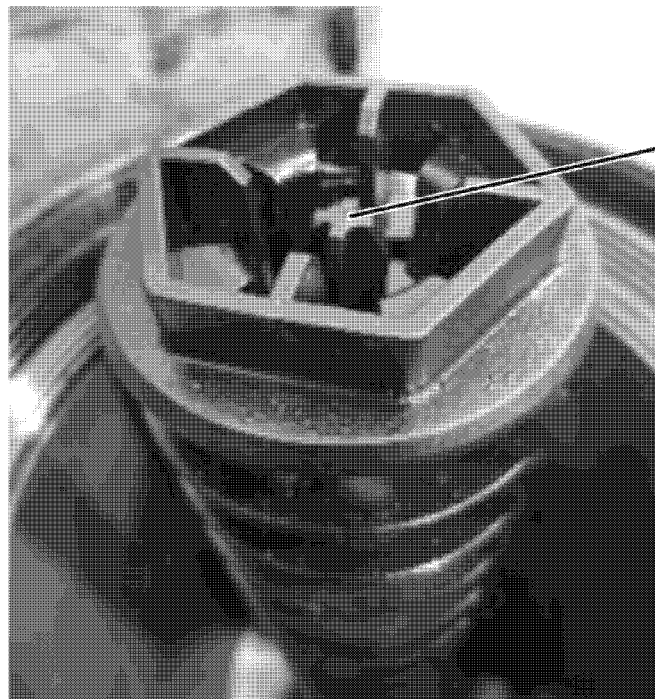
d180053

The oil filter bypass valve can be damaged during an oil filter change if care is not used when removing and installing the oil filter and cap. See figure below. The bypass valve can also become stuck open from foreign debris or engine parts. See figure below. Operating an engine with a missing, damaged or stuck open oil filter bypass valve could result in a debris-related, lower end bearing failure due to a larger amount of unfiltered oil entering the clean side of the lubricating system.

1. Broken Bypass Valve

**Fig 7.6, Broken and Missing Oil Filter Bypass Valve**

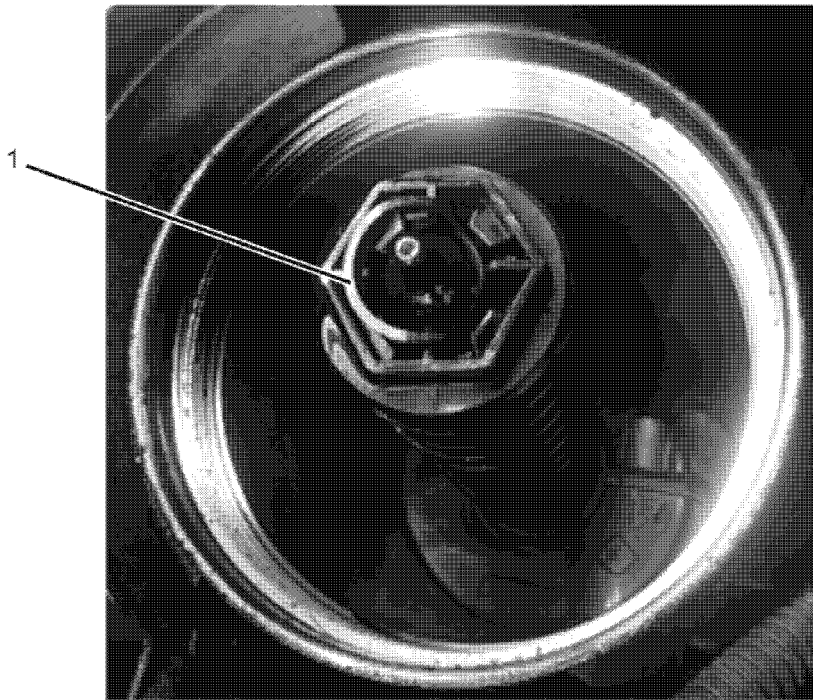
d180054

1. Foreign Material / Sealing Ring

**Fig 7.7, Stuck Open Oil Filter Bypass Valve**
